**MARYLAND HISTORICAL TRUST
NR-ELIGIBILITY REVIEW FORM**

PROPERTY NAME: George House **INVENTORY NO.** CAR-348
ADDRESS: 23648 25204 Shore Highway, Ridgely, MD 21660-1847
OWNER: Derrick N. and Catherine Comfort
TAX PARCEL NUMBER: 113 **TAX MAP NUMBER:** 27
PROJECT: MD 404 from US Route 50 to Denton Bypass **AGENCY:** MD SHA
SITE VISIT BY: Archaeological and Historical Consultants, Inc.
NAME: Wendy Zug-Gilbert **DATE:** July 2001

NAME: George House

DATE: c. 1890

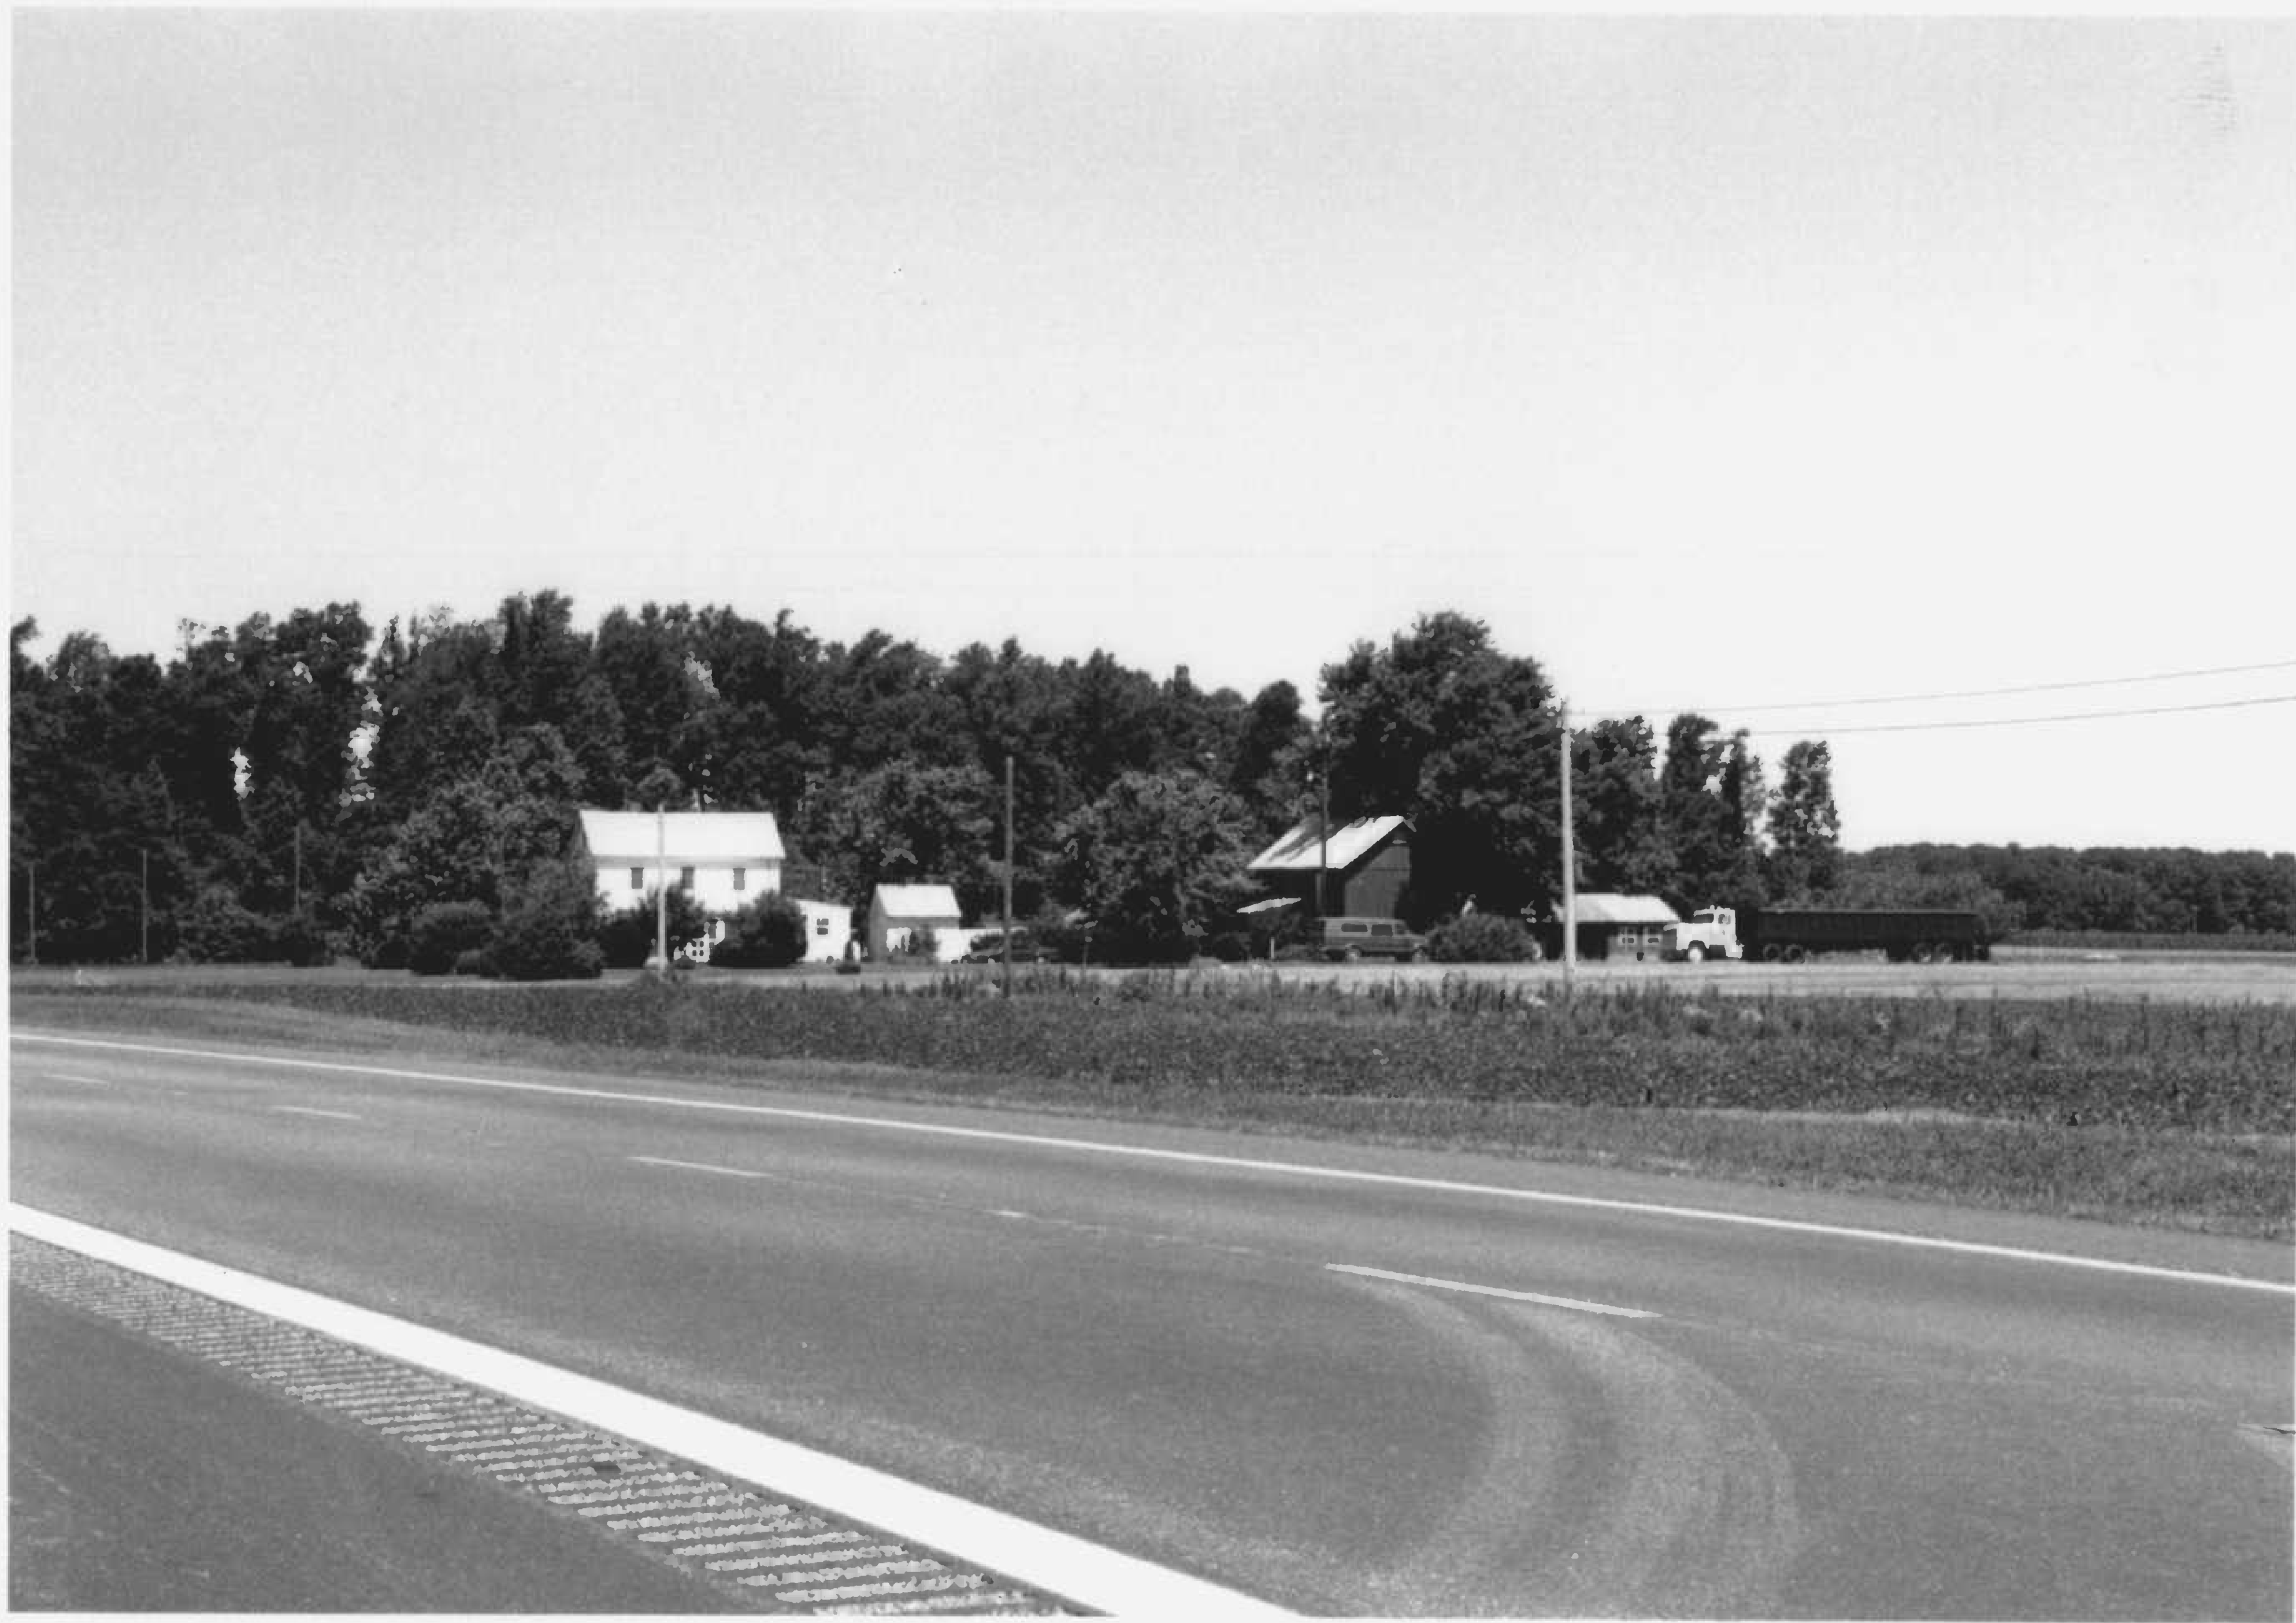
1 of 7

The George House is located on the north side of Maryland Route 404, between Ridgely-Bridgetown Road (MD 312) and Holly Road, west of Denton in Caroline County on Maryland’s Eastern Shore. The house and its small collection of outbuildings may have once been the core of a small farm. Currently, the house and outbuildings are located on a 1.2-acre lot that was parceled out of a larger property within the past 20 years. The house sits on a slight rise between tributaries to the Choptank River and Tuckahoe Creek. The property includes a residence, a meat house, a barn (carriage house), and a machinery shed.

Overview of property, facing northwest

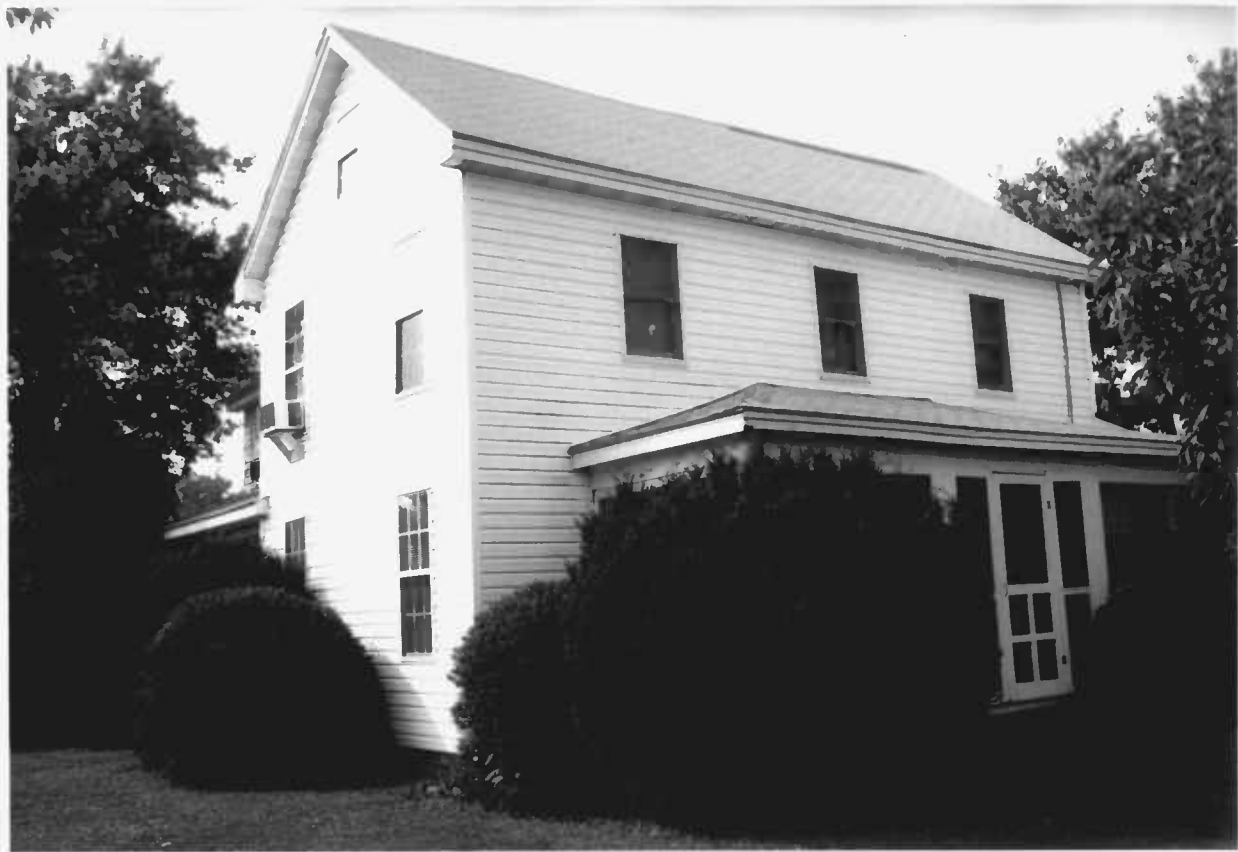
2 of 7

The George House is a two-and-a-half-story, frame, vernacular dwelling covered with vinyl siding on a brick foundation. The orientation of the structure is confusing – from the highway to the south, the dwelling appears to have a gable-front-and-wing plan; however, the enclosed hipped-roof porch and three-bay fenestration on the gable-front’s eastern side elevation give the appearance of a dwelling façade. If the latter configuration is correct than the residence would be facing east with its southern side elevation fronting on the highway and would have a rear kitchen wing (the wing section). A porch is located in the southern ell of these two units. A one-story addition is situated on the northern gable end of the dwelling. Asphalt shingles cover the roof. A single brick interior chimney is located on the ridge of the westernmost gable. Windows are a combination of six-over-six and four-over-four sash.

House, east elevation, facing northwest

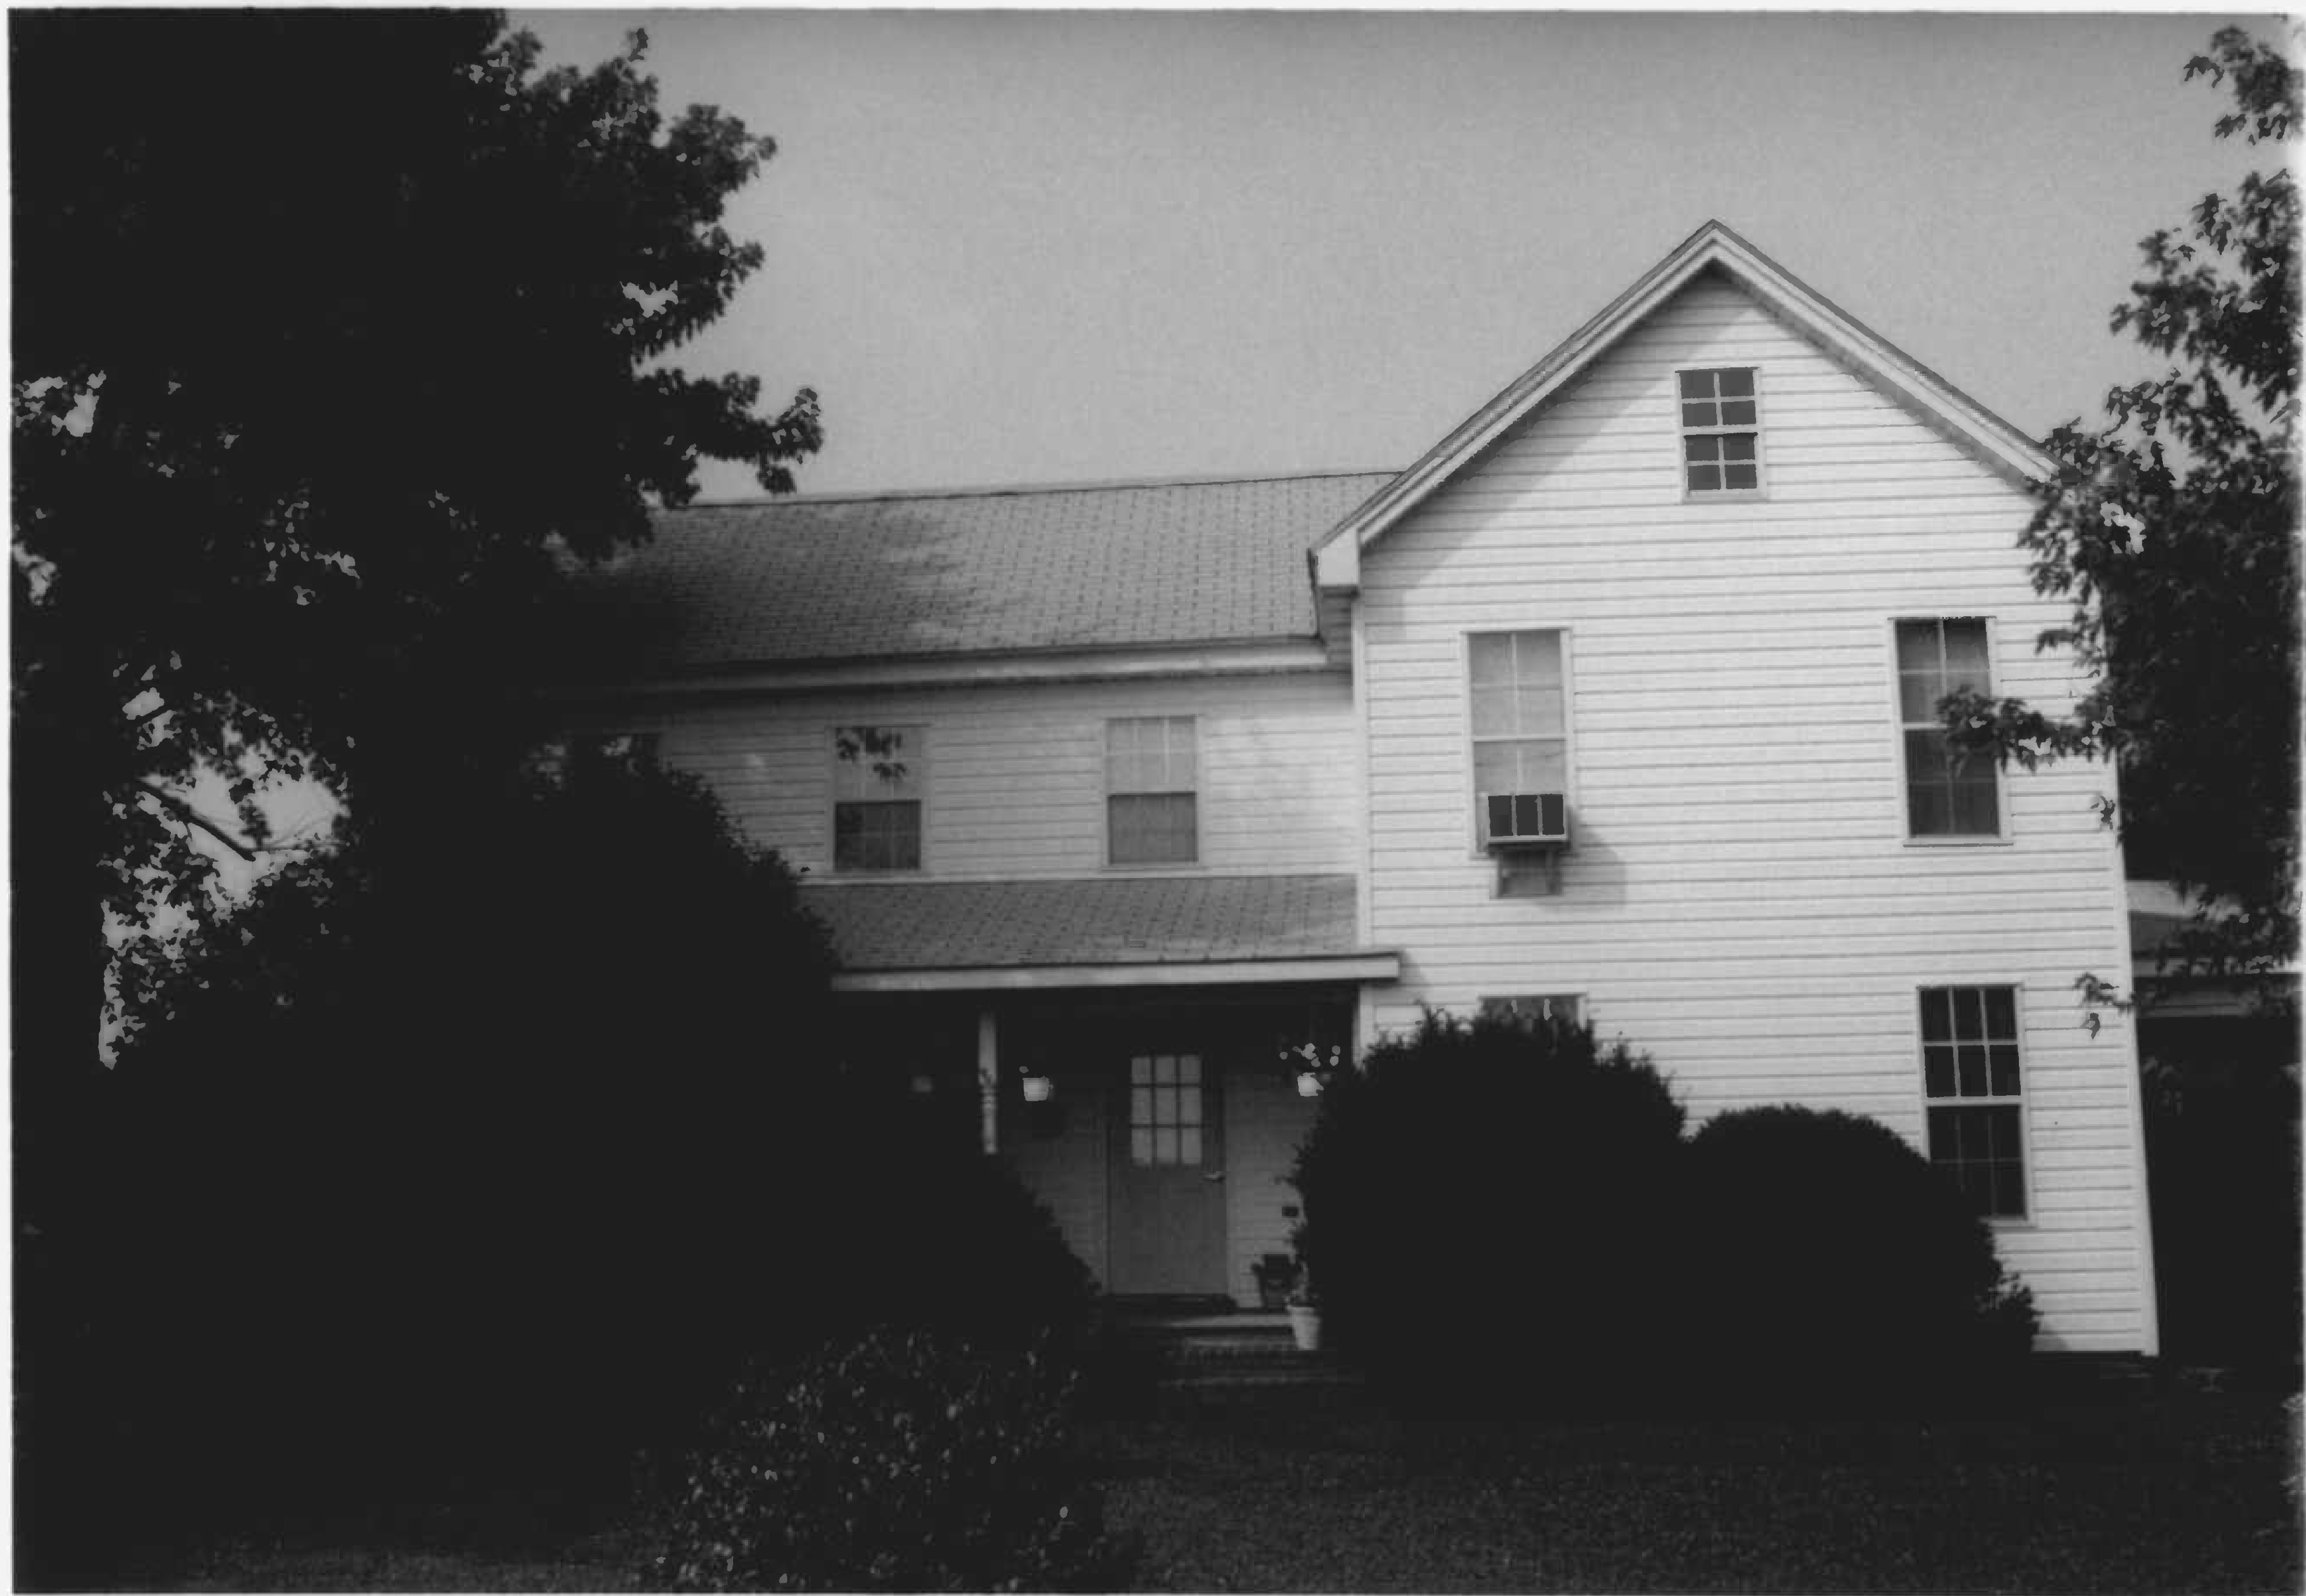
3 of 7

House, south elevation, facing northeast

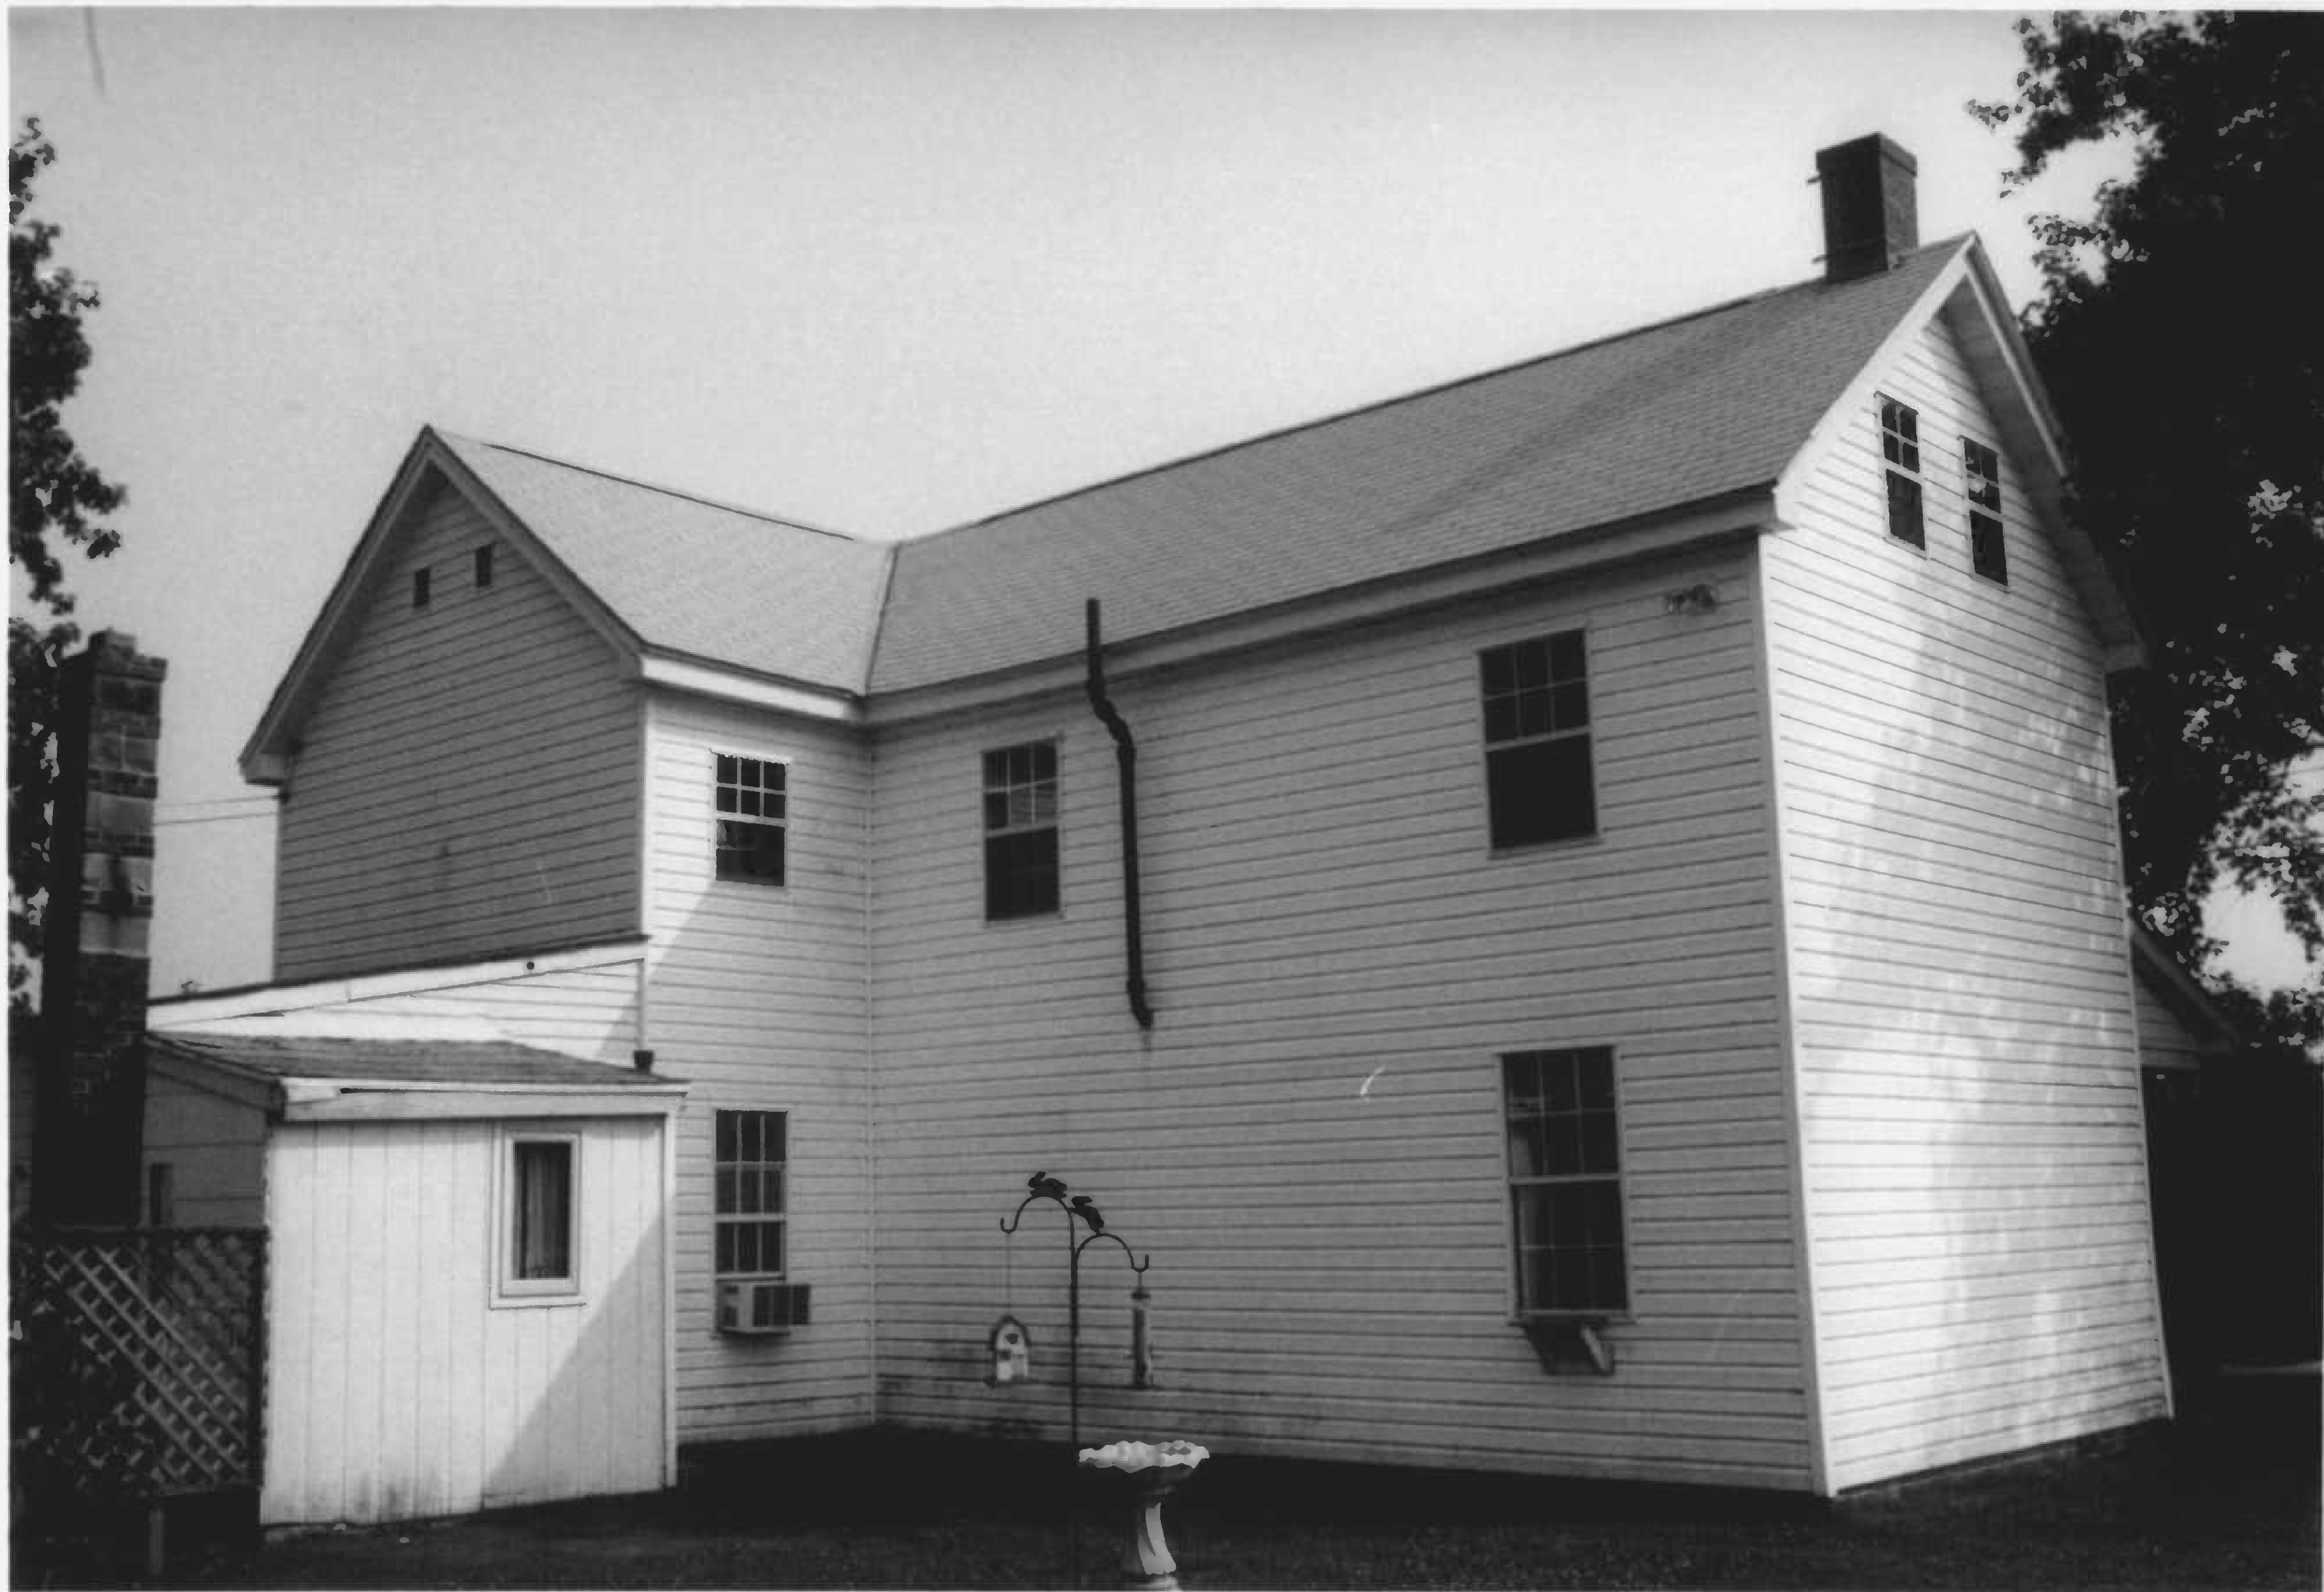
4 of 7

House, west elevation, facing southeast

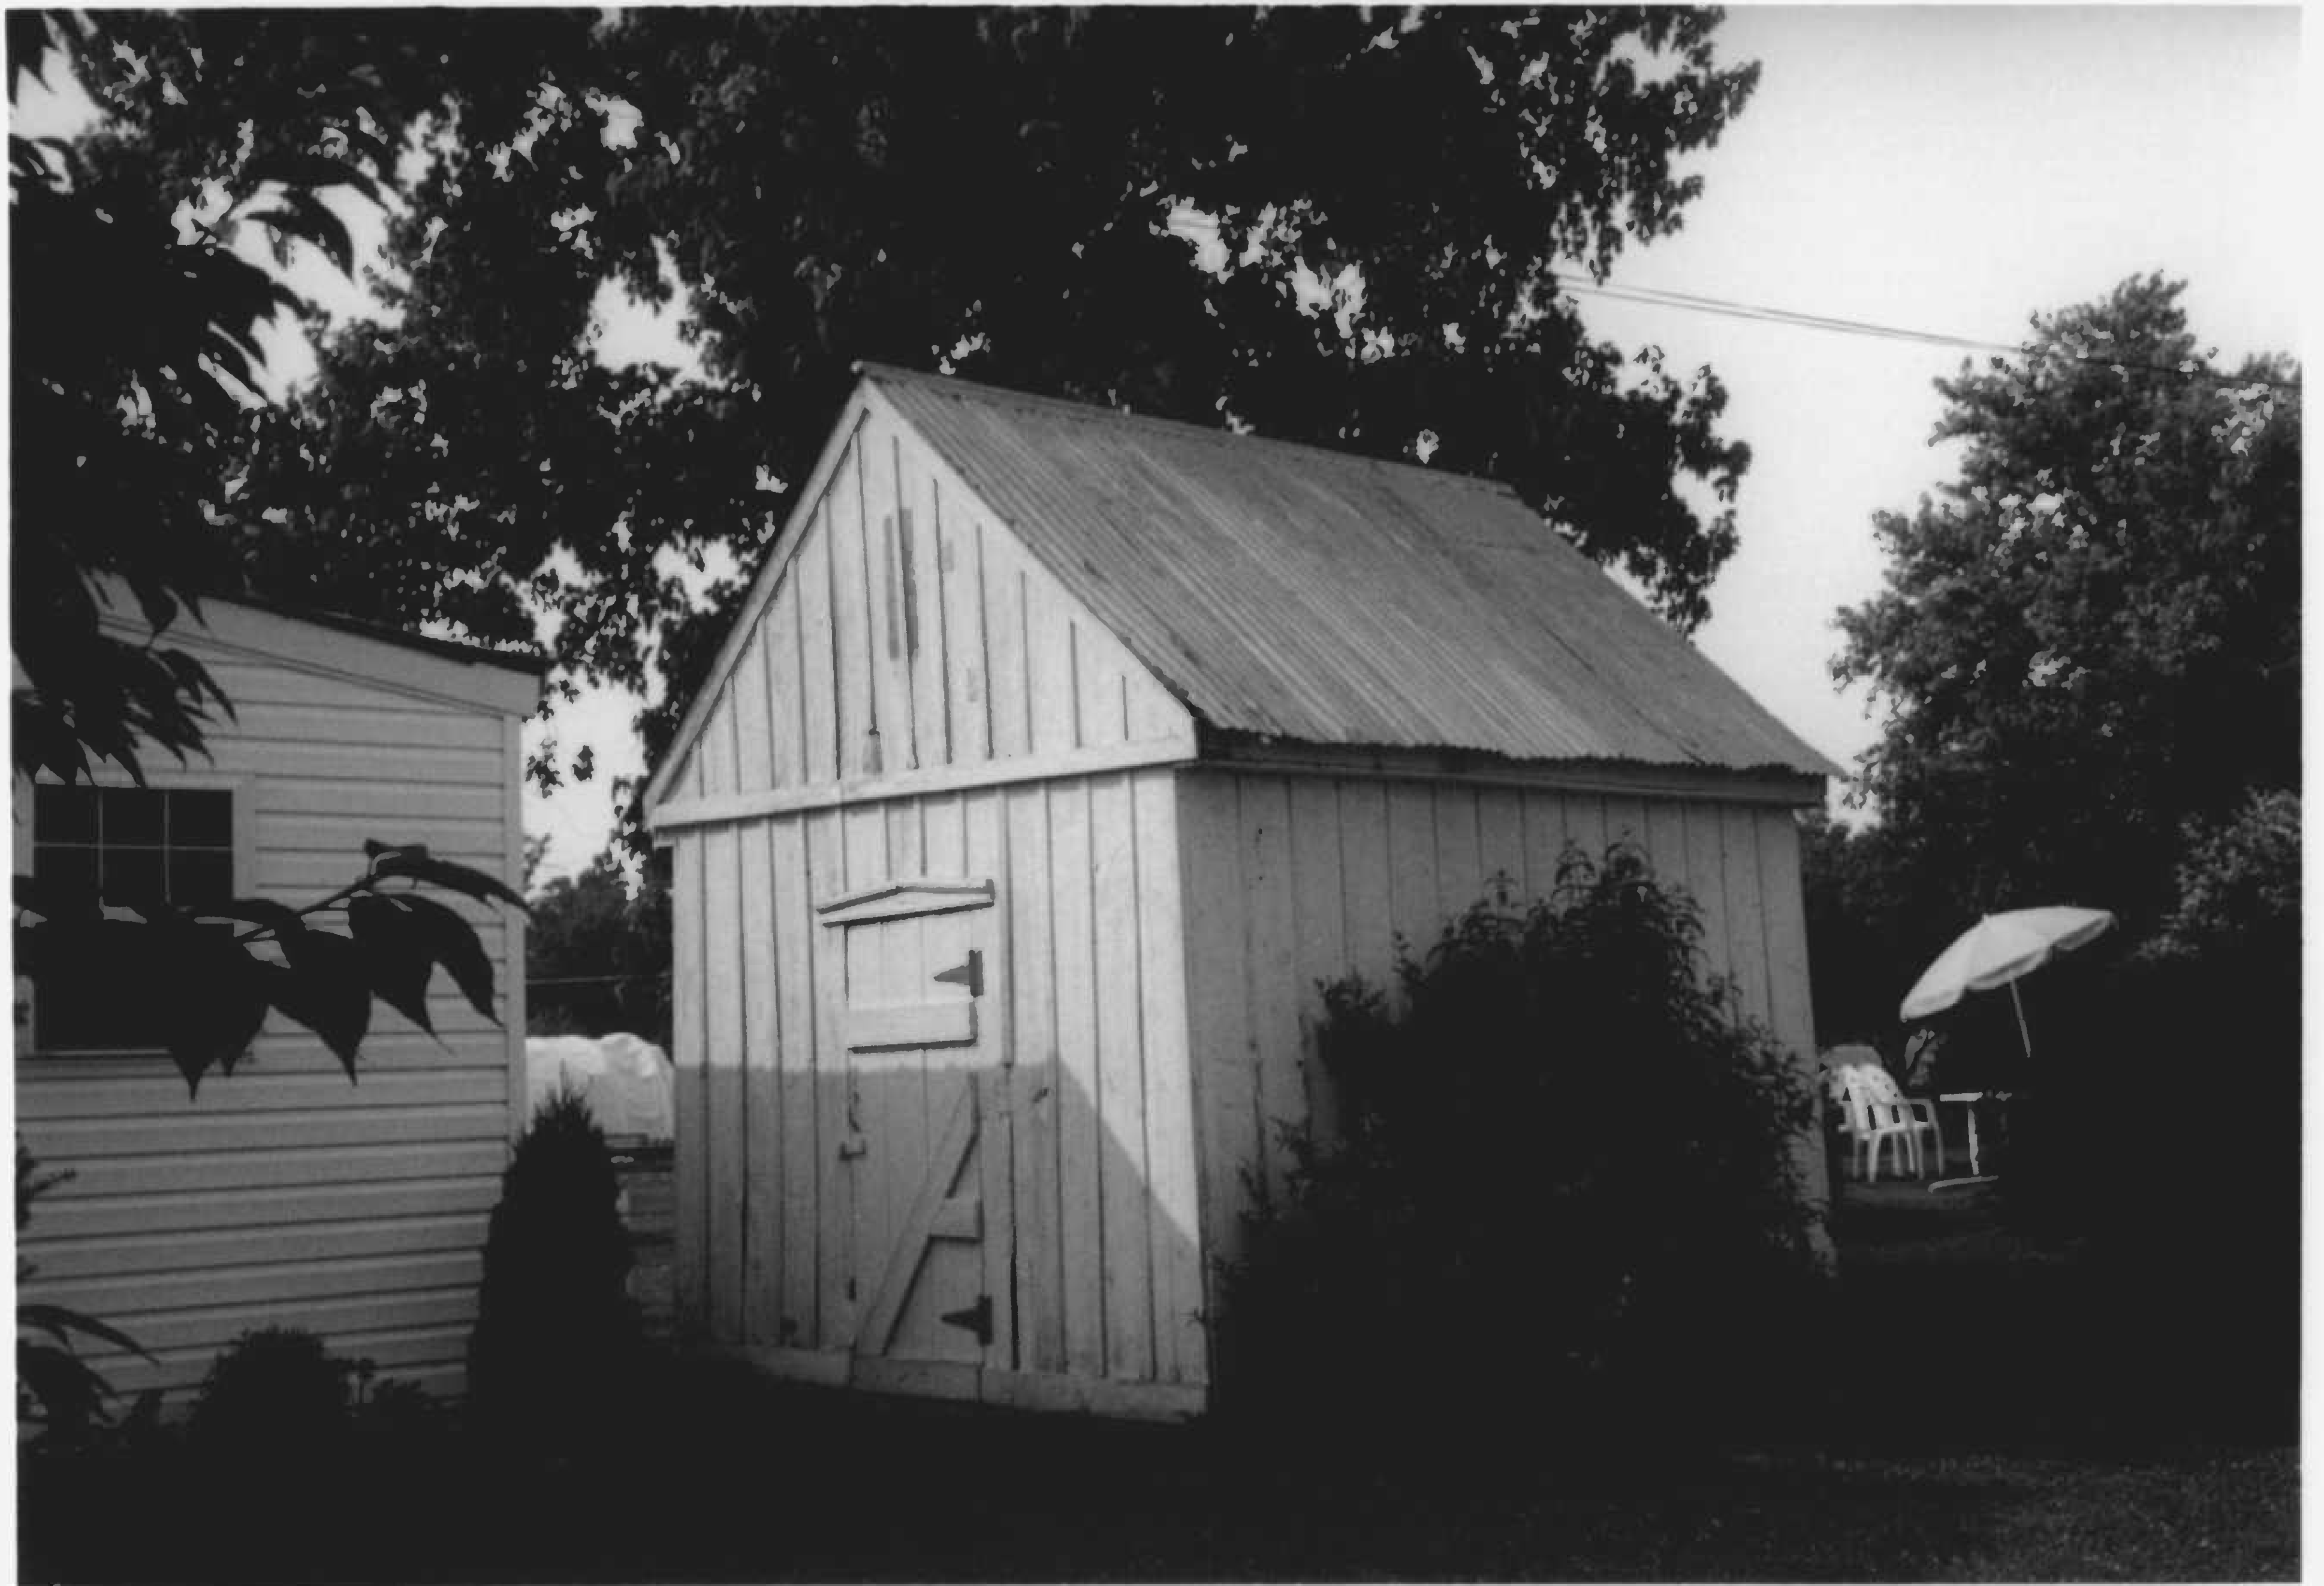
5 of 7

A former meat house is located immediately north of the house. It is a small, square, front-gable building constructed with board-and-batten siding and a corrugated metal roof. The meat house has a single batten door on the south elevation. A one-and-a-half story barn is located to the northeast of the house. It is constructed with vertical wood planks supported by brick pilings and piers, and has a corrugated metal roof. A shed-roof extension is attached to its west elevation and provides an additional two bays. The barn is currently used for domestic storage. A frame and concrete-block machinery shed is the property’s northernmost improvement. It has three open bays on its east elevation and an enclosed section on the northern end, which is used as a chickenhouse. The structure has a modern corrugated metal roof.

Meat House, south gable end, facing north

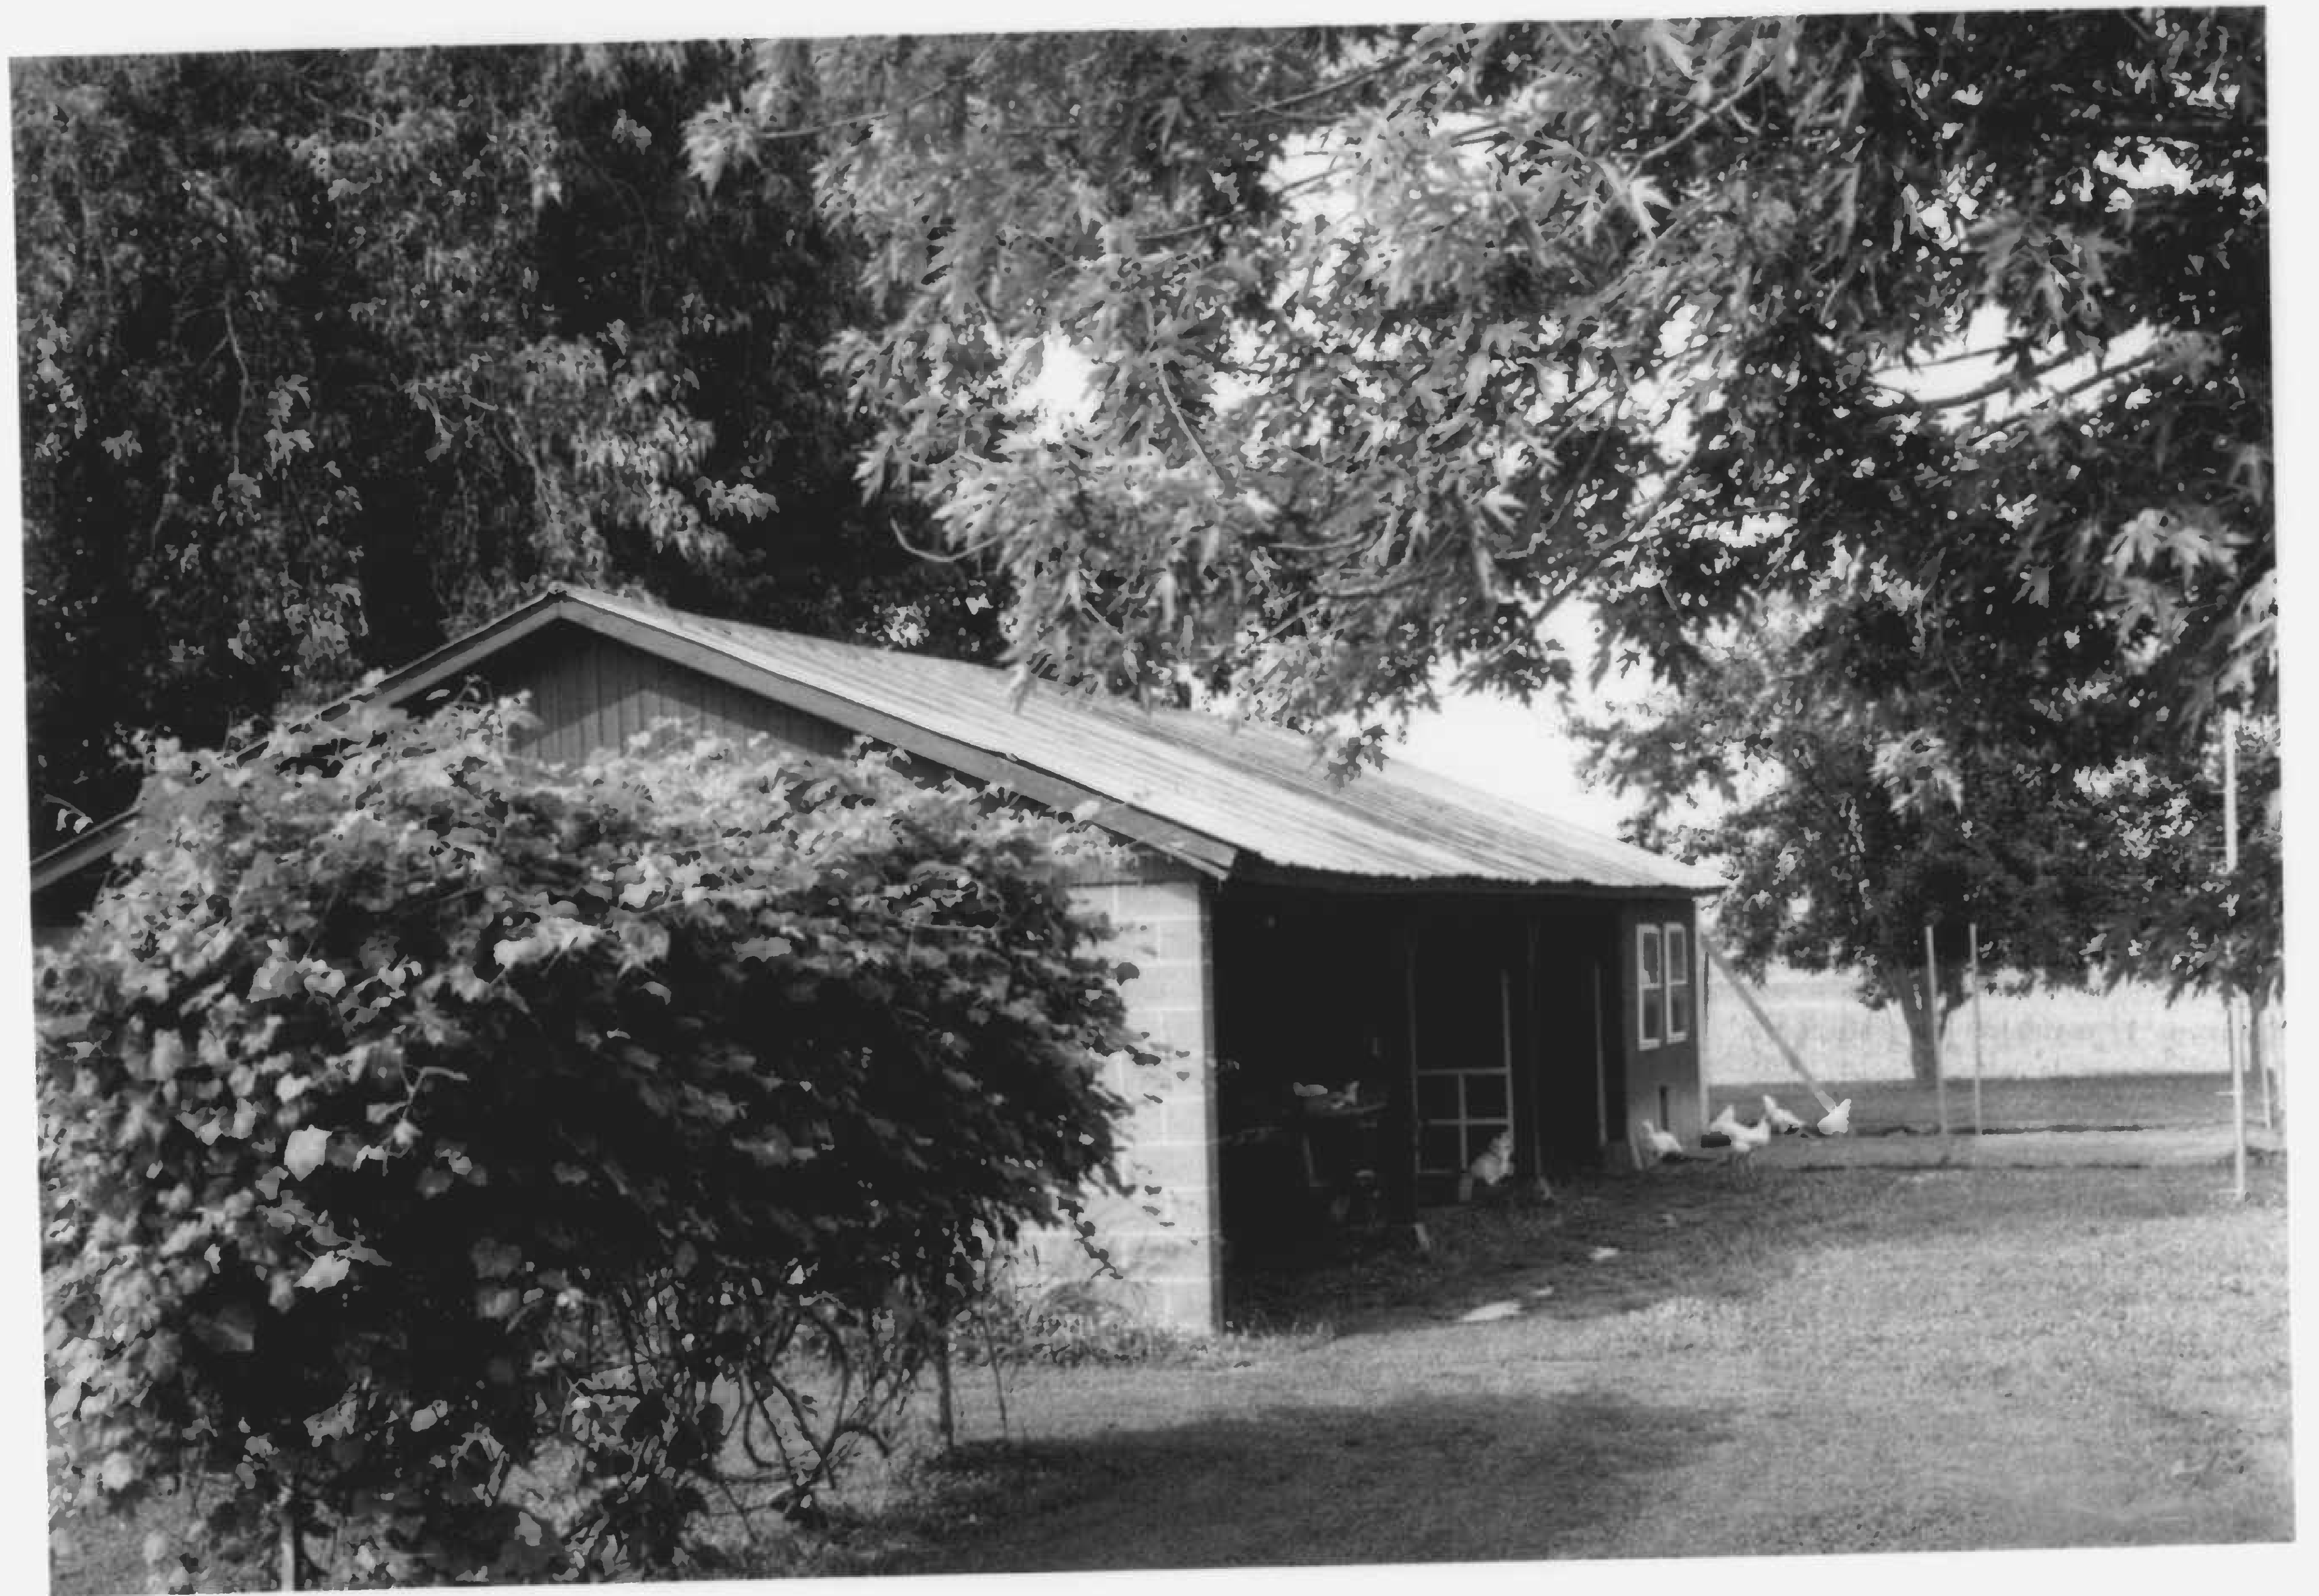
7 of 7

Machinery shed, garage, open east elevation, facing north
